Mississippi Gulf Fishing Banks, Inc.

Activity Report for the Period June 11 thru July 9, 2015

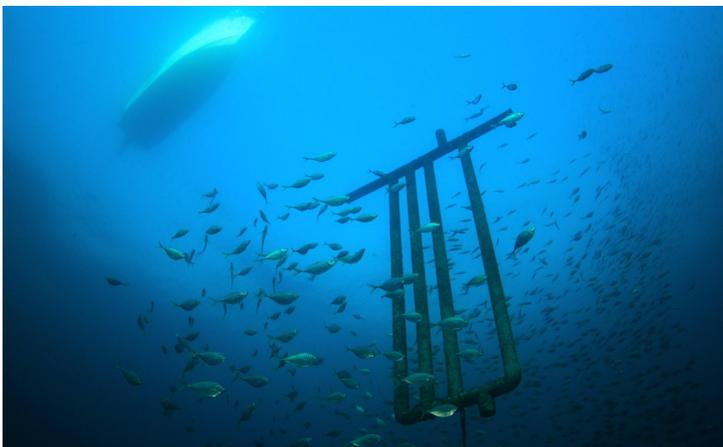
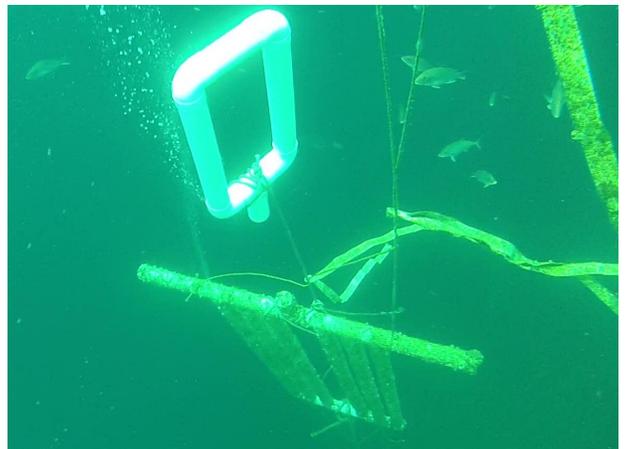
On May 29, a visit was made to FAD2 on the Jumbo Barge in FH-7 (<https://youtu.be/QPEq-dHe-50>). The device was found sitting upright but on the bottom. Some air was added but a severe leak was noted so a repair trip was made on June 1 (https://youtu.be/sjX7haL0_wQ). A smaller FAD unit was tied to the top and air added to give it buoyancy. It was surprising to see FAD2 still floating in the upper water column despite the leak previously noted. FAD2 was deployed on October 29 and does not have as much growth as FAD1 but the barnacles are larger. FAD2 is proving effective in attracting Cigar Minnows and juvenile Amberjack which would otherwise be absent.

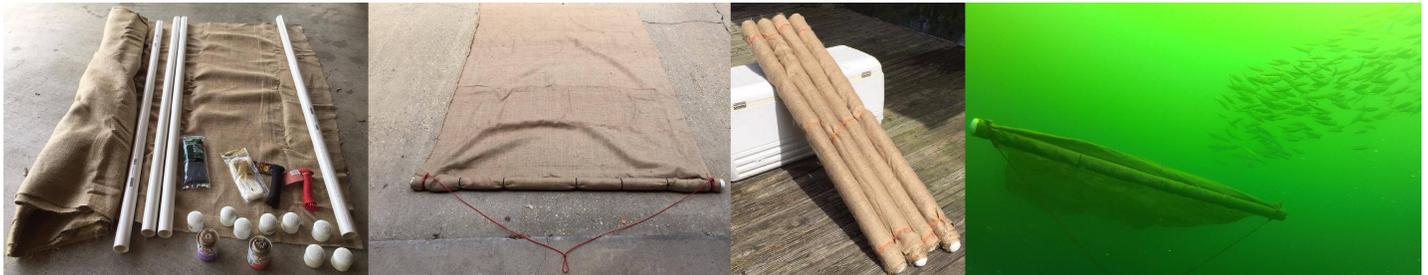
FAD3a, FAD3b, FAD3c, and FAD3d. [Trip Gallery](#)

A new design was implemented and called FAD3 since this is our third FAD construction attempt. The idea was taken from units that were seen in Destin earlier this year (See <https://youtu.be/npjSGnqGLyE>). The design is simple consisting of burlap material measuring about 5' X 8' and attached to a 1-1/2" Schedule 40 PVC Pipe. The unit is flown like a horizontal flag. It can be attached to a weight and used stand alone or attached to a wreck. In this case we are attaching to other material so we can easily find and monitor their progress. The material consisted of an 8' X 5' burlap attached to a 1-1/2" PVC pipe that is capped and sealed. A bridle was tied on and the unit could then be rolled up for convenient transport. Once onsite the appropriate amount of downline was added and the unit was rolled back up for transport down to the reef. The cost of each unit was about \$25 in material. The breakdown was as follows. Burlap, 60" wide at \$1.30 per foot or \$10.40 per FAD. PVC pipe 1-1/2" X 5' at \$4.14 per FAD, PVC Caps at \$1.58 each or \$3.16 per FAD, 100# Paracord at .16 per foot or \$1.60 per FAD, Cable Ties at .08 each or .40 per FAD. Downline is .10 per foot (1/4" Polypropylene).
