# Mississippi Gulf Fishing Banks, Inc.

## Activity Report for the Period July 9 thru August 13, 2015

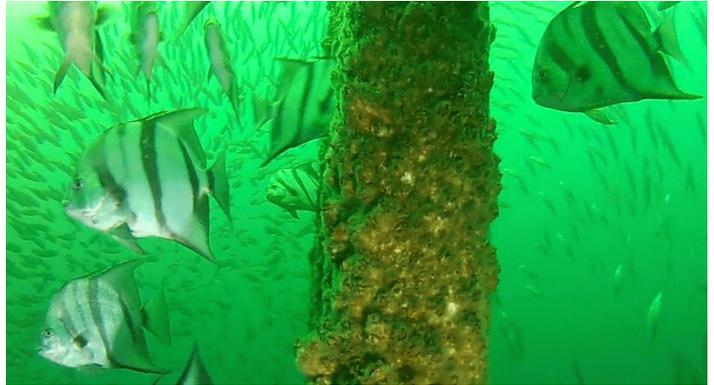
On July 23, a visit was made to the Southern Star Shrimp Boat which also has carpet FAD3a attached. Observations showed an exceptional population of Red Snapper and baitfish. Spadefish were observed scratching themselves on carpet FAD3a. After that dive a visit was made on nearby FAD1/FAD3b. FAD1 is a 10'x5' PVC Sewer Pipe FAD that was deployed on August 10, 2014. Carpet FAD3b was attached to the top of it on July 4. FAD1 has been underwater for about a year now and has significant barnacle encrustation and even some sea urchins attached. Cigar Minnows and Spadefish also thrive. The FADs are performing well. There was some carpet entanglement which may need to be addressed depending on future observations. Perhaps some small floatation on the tail edge of the carpet to keep it floating higher than the PVC pipe end.
