Mississippi Gulf Fishing Banks, Inc.

Partial Activity Report for the Period July 11 - August 14, 2003

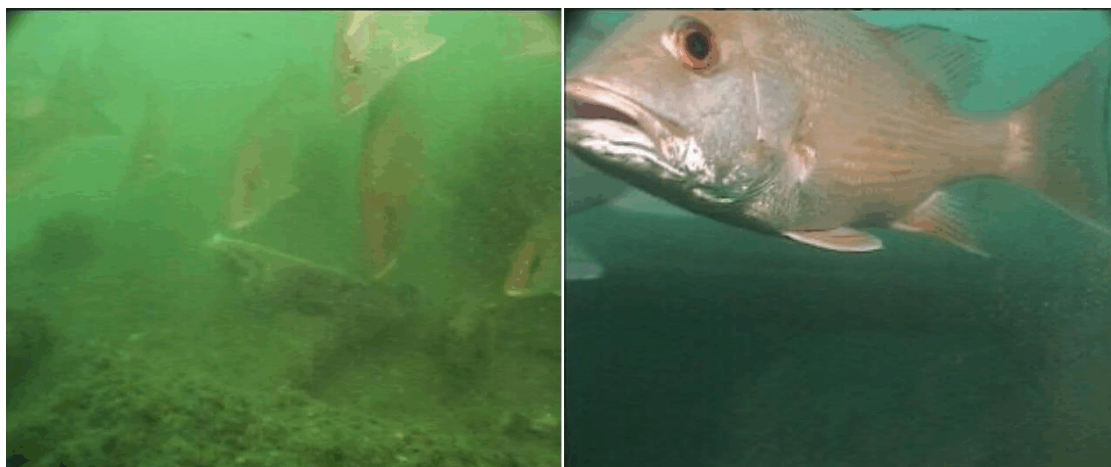
020703 Rubble GCRL-2 NE 264F13

On August 3, a visit was made to this year old rubble pile placed here for the Gulf Coast Research Lab to use for their red snapper cultivation project. Fish observations included red snapper (50-75/1-3lbs.), Triggerfish (25-50/1-2lbs.), Gag Grouper (4/3-6lbs.), and Tom Tate (10-15). Most of the fish were hovering in the upper mid-water, but several followed to the bottom. The reef appears to be progressing well.

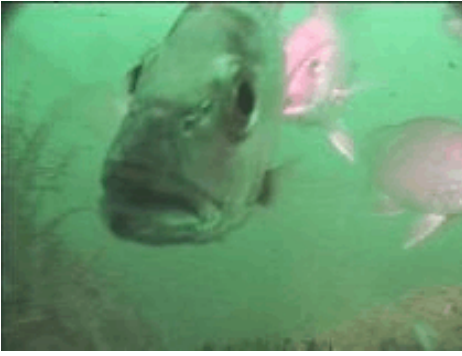
APC 298F2

Following the rubble dive and enroute to the Chicken Coop Towers, it was decided to stop and take some video of this APC in FH-2. Fish observations included Red Snapper (50-75/1-3lbs), Triggerfish (20-25/1-2lbs.), Mangrove Snapper (6-8/1-3lbs.), and Tom Tates (10-15). The reef is progressing well, with encrustation beginning and the fish are freely swimming in and out of the structure. Visibility was not great (5-10 feet), but better than previous attempts of getting video footage.

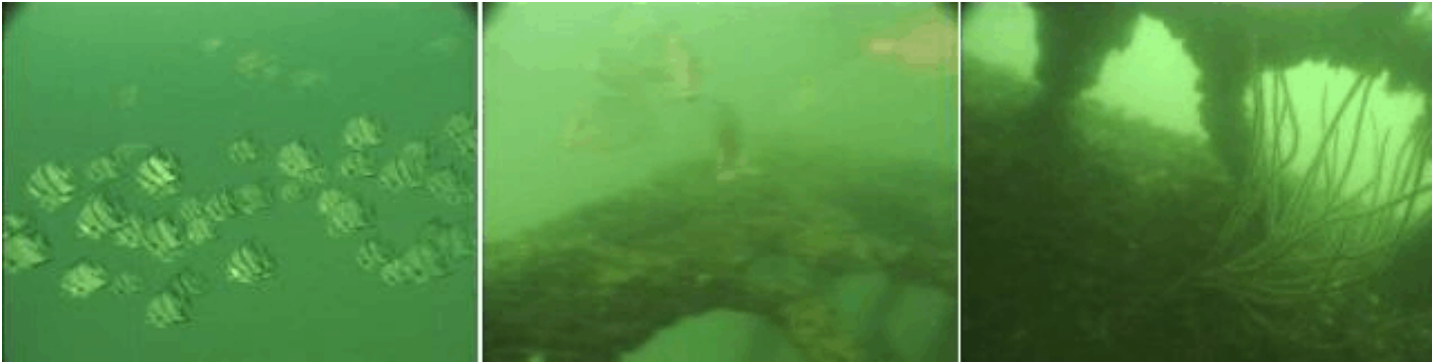
010125D Chicken Coop Towers 16-19 241F2

These 3 Steel Towers have a concrete base of about 5 feet square and a steel cage of about 10 feet in height. Deployed in late January of 2001 and visited once in June of 2001, it was deemed time for an inspection. The towers in FH-13 are believed to have been hauled off by a shrimp boat, but these 3 towers still remain. However, two of them have laid over in the sand and no longer stand upright. Nevertheless, they still provide some fish habitat, but not as effective. By laying over, the sand has buried over about 30% or more of the structure. Soft corals were observed attached to the concrete base, but don't seem to attach to the steel. Fish observations included Red Snapper (25-50/1-3lbs.), Triggerfish (4-6/1-2lbs.), Spadefish (50-75/1lbs.), sheephead (1/5-7lbs.), and a large sting ray buried at the base of the reef. Sea Urchins were also observed making a come back here. While these reefs do seem to provide some decent habitat, they seem to be too frail and too small when compared to materials of opportunity.

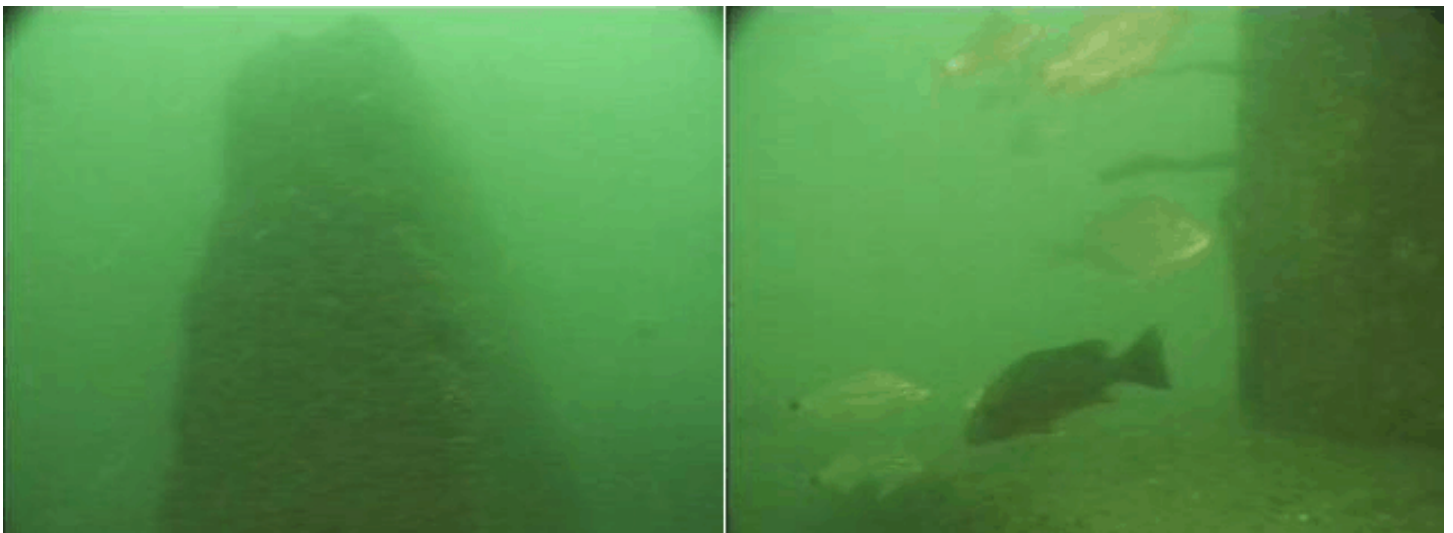
Following this dive, a dive was made on the Jackson County Barge to obtain video only. It is worth noting that fish observations were good, but fishing pressure does seem evident when compared to other reefs in the area. Also on August 10, a dive was made on 020919 rubble in FH-13 to take some video. Observations were encouraging as many snapper and grouper were in the area and smaller animals like arrow crabs, hi-tops, and damsels were seen making a come back.
