Mississippi Gulf Fishing Banks, Inc.

Activity Report for the Period February 14 - March 13, 2003

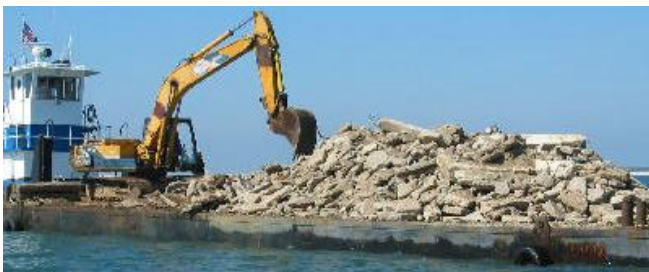
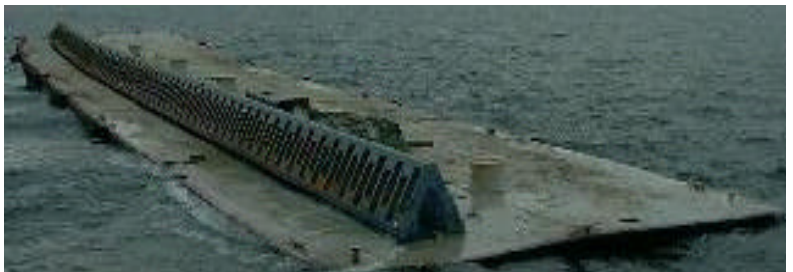
On March 11, a trip was made to the Casino Magic Barge to get video and make observations as to the progress of this four month old reef. Conditions were difficult with cold winds and a strong 4 knot surface current. Visibility was only about 6 feet, but good enough to make some observations. A technical problem with the video camera rendered the footage unfocused. Since the visibility and conditions were poor, a repeat dive was deemed unnecessary. This dive took place at the Stern of the Barge so that observations of the 2 APC's could be made as well. Observations revealed the reef to be progressing quite nicely. An abundance (200-250) of juvenile snapper near the legal size limit (1-2lbs.) were seen as were a half dozen or so larger ones (6-10 lbs.). A single 6-8 pound gag grouper was sighted as were a half dozen sheepshead (2-4 lbs.). Barnacle encrustation was quite evident and oysters were also taking hold near the bottom of the barge. The APCs were a good enhancement to the barge as was the wave attenuator structure that runs down the port side of the barge. Red Snapper were readily swimming thru both structures and would follow the diver as he swam thru the APCs. The Gag Grouper sighted made his get away by swimming thru the wave attenuator structure. This may prove a problem to fishermen trying to land these fish.
