Mississippi Gulf Fishing Banks, Inc.

Activity Report for the Period August 13 thru September 10, 2009

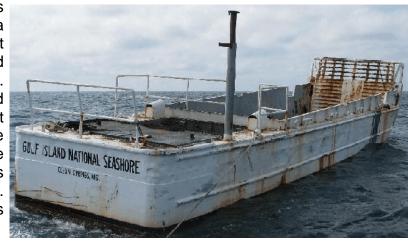
081011a Elsie M Landing Craft, 490F1

This 50' X 16' Landing Craft was donated by the Gulf Islands National Seashore after replacing the aged vessel. They used this vessel to transfer equipment from the mainland to the National Seashore Islands off Mississippi. This was the first visit since her October 11, 2008 deployment. Visibility was not ideal, but several juvenile red snapper and Triggerfish were sighted in addition to schooling bait fish like

TomTates and Blue Runners. The Vessel is facing in a generally West direction with a Starboard mast head reaching the highest point at about 55' from the surface, followed closely by the bow landing grate at about 57'. Depth measurements along the starboard side and along the deck was 63' with the aft railing reaching to 60'. The Port side measured about 61' denoting a slight list. The bottom measured around 69' under both ends with the surrounding depth reading about 68'. Overall the reef is performing well but needs some more time to develop.

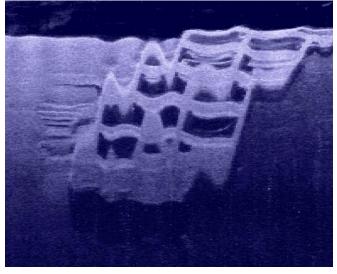
011114 Corps Barge 259F2

This 200 foot work barge was sunk on November 14, 2001 in the southwest corner of FH-2. The bow is facing in a southwest direction and the coordinates were recorded at 30°04.770'N/88°34.624'W. The Stern is at 30°04.785'N/88°34.592'W. Previous visits have been made on 11-18-01, 5-25-02, 7-13-02, 5-24-03, 10-4-03, and 4-10-04. Initially this reef had a minimum depth of 34 feet due to an upper deck

structure that has since been ripped off by Storms, leaving the reef with a new minimum depth reading of 56'. Visibility was extremely poor at the structure which pretty much made observations fruitless, however, significant soft corals were noted growing on the deck and several snappers, triggers, and bait fish were observed. In addition, a game sized cobia (~30 lbs.) was seen in the upper clear water near the surface. It was also noted that there was significant silt collecting on the reef itself and may be hampering encrustation of barnacles and other life. Side-Imaging showed numerous holes throughout the length of the barge. Otherwise the reef is still showing to be viable despite its nearly 8 years of age.
