# Mississippi Gulf Fishing Banks, Inc.

## Activity Report for the Period April 11 - May 9, 2013

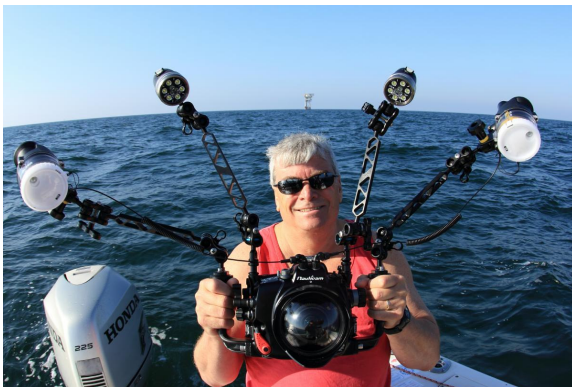
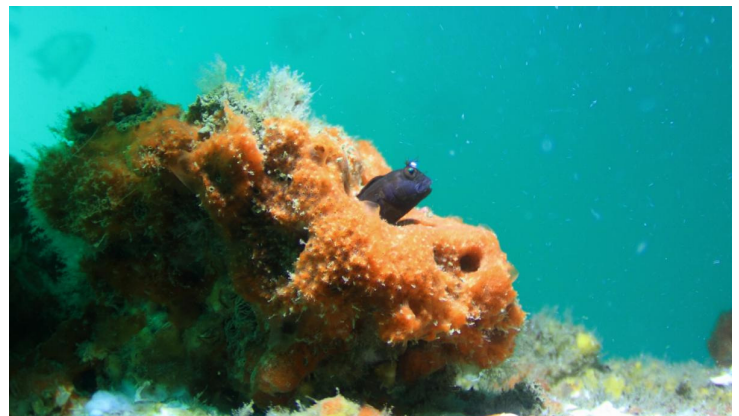
### **060624 Mike Jenner Tug Boat 435F13**

This 145' River Tug Boat is sitting upright at the South end of FH-13. This trip was to try out the new camera system that was recently purchased. The system is a Canon 7D Camera with a Tokina 10-17mm lens, a Nauticam Underwater Housing, (2) Sola 2000 S/F LED Video Lights, and (2) Sea & Sea YS-D1 Strobes. This yields a professional quality picture and video system for documenting the reefs. Unfortunately the recent flood waters caused the visibility to be under 5 feet from top to bottom. Considering the poor conditions, the Camera test went well for getting acquainted with the setup and still yielded some pictures.
