Mississippi Gulf Fishing Banks, Inc.

Activity Report for the Period August 13 thru October 8, 2015

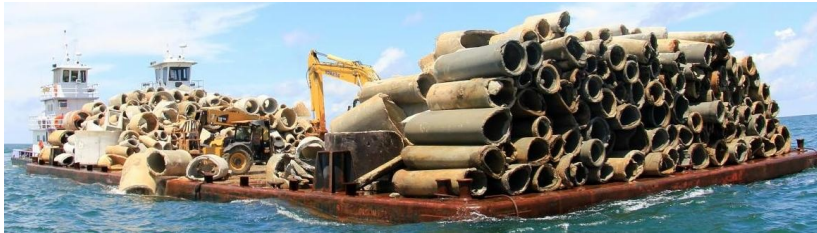
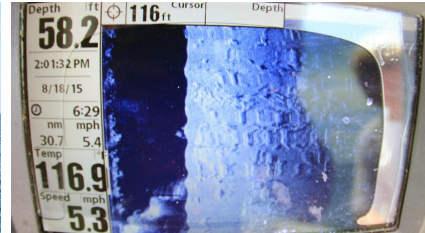
150818A Culverts 563F2 Position: 30°05.379'N 88°34.480'W Depth 57'

150818B Culverts 564F2 Position: 30°05.319'N 88°34.324'W Depth 57'

These deployments were made on August 18 with the tide neap at a level of 1.2' with a range of 1.1-1.3 feet mlw. The area is northeast of the Colle Tug and southwest of the 080423 Rubble. While waiting for the tardy deployment barge to arrive, some excellent video of feeding snapper was taken (<https://youtu.be/O52A3E7IqGo>) on the Corps Barge (011114-259F2-30°04.776'N 88°34.608'W) and some first time video of the 150713A Culverts (<https://youtu.be/rNcOJSF6ZYI>) showing juveniles and even some game fish already taking residence. A minimum depth of 50' was recorded with the surrounding depth measuring 59 feet. Full gallery: http://gallery.primofish.com/2015/Fishing_Diving/MGFB/Deployments/150818_Culverts_Corps_Barge_150713A/

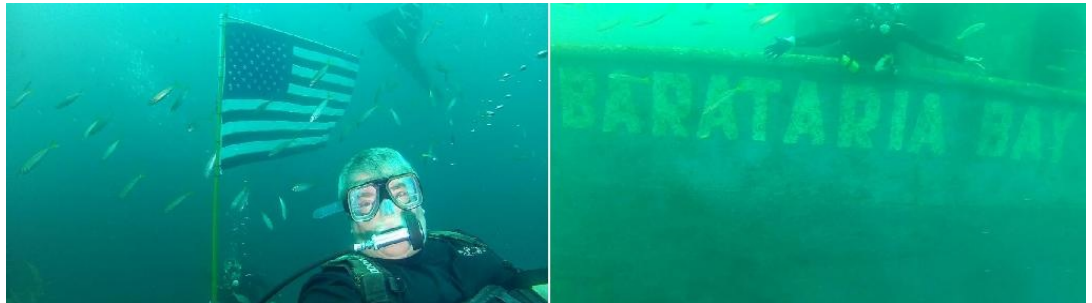
150610 Barataria Bay 552F13

The Mississippi Department of Marine Resources contracted Reefmakers from Orange Beach, Alabama and deployed the Pogie Boat "Barataria Bay" on June 10, 2015. This September 5, 2015 visit showed the reef is off to a great start. A significantly large population of Blue Runners and Cigar Minnows cover the structure.

While only a few game fish, like Mangrove and Red Snapper were sighted, they will be coming with all these baitfish. An 8'X5' American Flag was deployed on top of the wheelhouse using a derelict fiberglass sailboat mast inserted and tied to an existing pipe. A 1/2" PVC pipe was formed in an "L" and used along the top and end of the flag to keep it standing out. Two carpet flags that were deployed on July 4 were entangled with each other and left that way since they were still functioning. The top one was showing some deteriorated holes but still functional. They were recorded at 39' and 25' depths in the water column and significant algae growth and small organisms were noted.
