Mississippi Gulf Fishing Banks, Inc.

Partial Activity Report for the Period May 13 - June 10, 2010

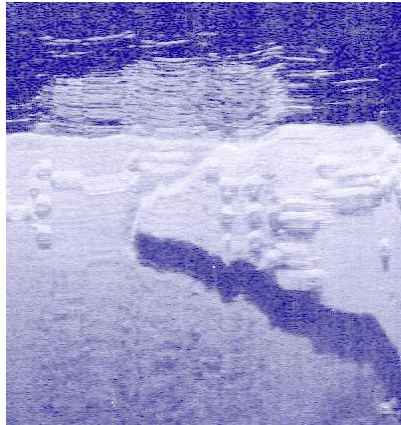
840701 Barge-A 21F1

This 180' X 70' X 12' Barge was sunk in the Summer of 1984. Despite its age, the overall structure, including the deck, has held up very well. It has showed very little scouring or deterioration for unknown reasons. On November 8, 2001 the reef was augmented by concrete rubble, some of which landed on top of the barge. Due to its success, Reef Balls were deployed on top of the Deck as well as the surrounding area on October 6, 2009. This was the first visit since that deployment. The observations showed the

added Deck Material to be a very effective enhancement to the reef. The floating line FADs were also effective. Fish observations included Spadefish (100-150), Triggerfish (15-20), Red Snapper (100-150/2-20lbs), Sheepshead (5-8), Mangrove Snapper (10-15), and a Blue Angel. Numerous Soft Corals were common on the Barge Deck.

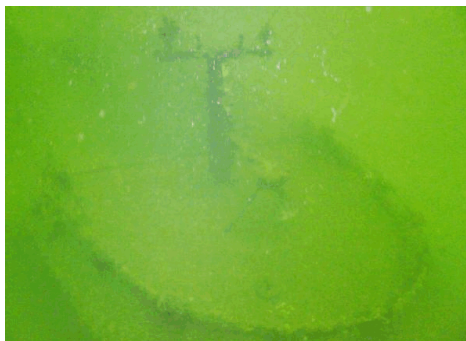
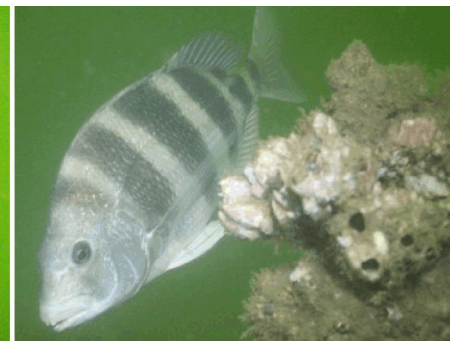
081011b St. Elmo Shrimp Boat 491F2

This 70' Steel Hull Shrimp Boat washed ashore in Pass Christian Harbor during Hurricane Gustav. The Harbor had a lien on the Vessel and somehow obtained ownership and donated it to the DMR. The DMR Derelict Vessel Program paid 100% to recover the Vessel, environmentally clean it, and deploy it in FH-2.

on May 22, 2010. The structure appears to be doing well with little deterioration. Fish Observations included Spadefish (75-100), Red Snapper (50-75/2-8lbs.), Triggerfish (8-12), Mangrove Snapper (6-8), Sheepshead (3/3-5lbs), and Cobia (2/10 & 40lbs.). Overall the reef is progressing very well.
