# Mississippi Gulf Fishing Banks, Inc.

# Partial Activity Report for the Period April 8 - May 13, 2010

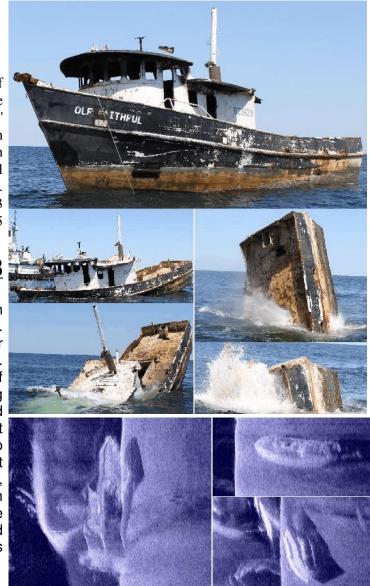
### <u>091124 Great Wicomico 517F13</u>

This 175' Pogev Boat was donated by Omega Protein and deployed in FH-13 on November 24, 2009. Previous attempts to visit the reef were met with poor visibility. This visit was much better, but still not ideal. Observations were only effective in the top 5-10 feet of the Structure. Below that, poor visibility and lighting hampered efforts. Most of the top of the structure and the railings measured 63' of depth with 61' measured at the top of light posts. There was a FAD that towered to 53' at the float. There was a horizontal laying mast that measured 73' of depth. Fish observations on this May 5, 2010 visit included a large school of small to medium Spade Fish, 2 large Trigger Fish, medium to large schools of Tom Tates (75-100), and a few small red snapper (15-20/<1lbs.). No other fish sighted, but this may be due to the poor conditions.
