# Mississippi Gulf Fishing Banks, Inc.

## Activity Report for the Period November 12, 2015 thru May 12, 2016

#### 150610 Barataria Bay 552F13

#### 140810 FAD1 Visit

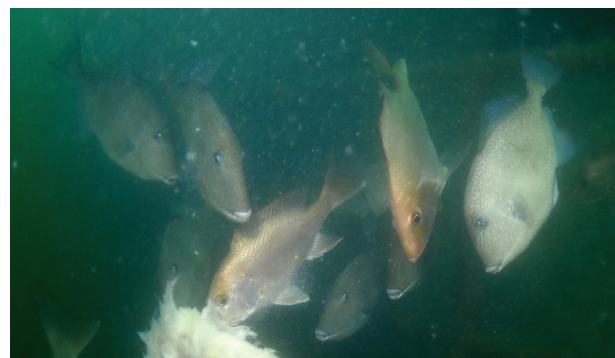
population of Triggerfish and Tomtates with a few Red Snapper mixed in. The May 7 visit showed many more Red Snapper and fewer Tomtates. Observations included a small lionfish was seen on the stern side of the wheelhouse. Also worth noting were some crabs and damsels utilizing the ecosystem saucers of Reefmaker's Grouper Reef. Both visits were met with relatively poor visibility and green anti-freeze like water. There were also noticeably fewer baitfish than previous visits and the lack of Sheepshead for this time of year was curious. However the reef is doing very well and is expected to flourish this Summer.

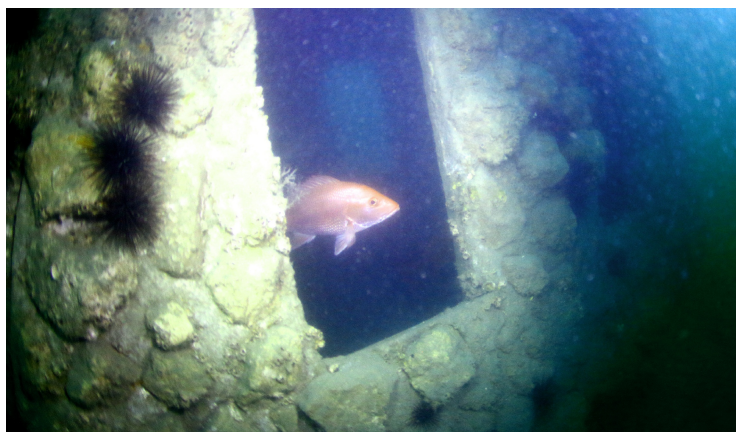
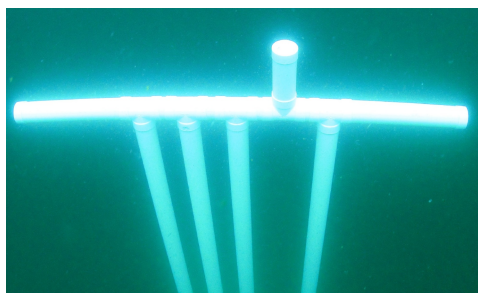
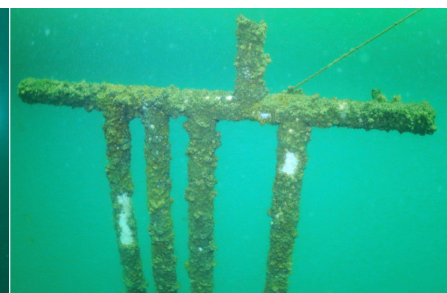
FAD1 was deployed on August 10, 2014. It was attached to one of 4 Pyramids designated in a grouping as 070306F in 76 feet of water. This location is just southeast of the Southern Star Shrimp Boat. The unit was constructed of PVC Sewer Pipe. See more details in the [deployment report](#). We did not know how long the unit would last but this May 7 visit is encouraging. Winter winds typically take their toll on objects like this which is what has made it extremely difficult to keep buoys on the fish havens. The unit is doing well and there were many more fish charted when compared to other nearby Pyramids. The marks appear to be mostly Red Snapper and Spadefish. A carpet FAD was previously deployed here as an extra enhancement. Although the burlap carpet has disappeared, the PVC float pipe continues to give extra height and provide more base for barnacles. This yields an idea to maybe make some "Ladder" FADs that consist of several float pipes lashed together. We will discuss this and possibly try it soon.
